Manhole Inspection Summary

Manhole # S49C__043MH

Insp Date: **12/3/08 2:04 PM**

Location Address: **rear 25 n milton st**

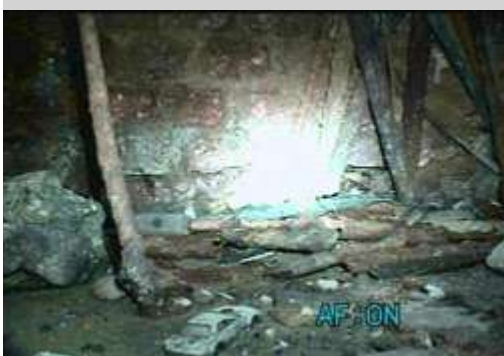
Miscellaneous

bench debris

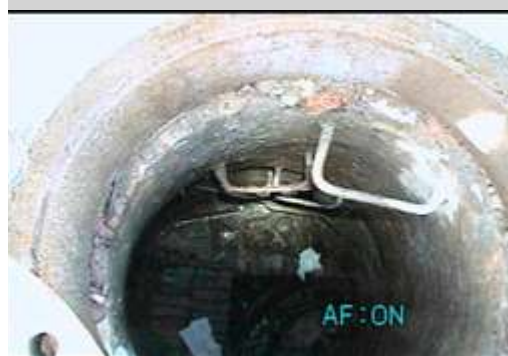
Defect 2

Steps Count: **5** Missing: **0** ☒ **Corroded**

corr steps

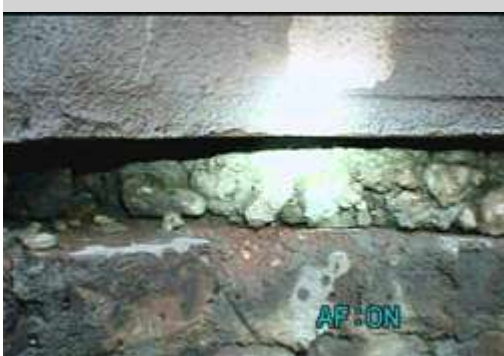
Defect 1

Chimney / Frame Adjustment ☒ Exists Material: **Brick and Concrete** ☐ Parged Height: **3** (in.)

Condition: ☐ Sound ☒ **Cracked** ☐ Root Intrusion ☒ **Loose Brick** ☒ **Deteriorated**

frame adj cracked, loose bricks,
deteriorated

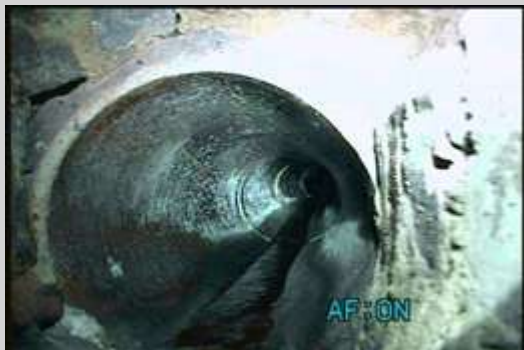
12 O'Clock Outflow

8 in. Circular Gravity Sewer
Pipe Out @ 12 O'Clock

Invert Depth: **9.50** (ft.) Flow Characteristics: **Slow**

Infiltration: **None** Pipe Seal Cond: **Unknown**

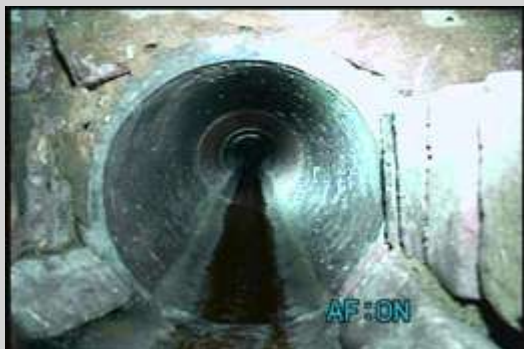
3 O'Clock Inflow

8 in. Circular Gravity Sewer
Pipe In @ 3 O'Clock

Invert Depth: **9.16** (ft.) Flow Characteristics: **Slow**

Infiltration: **None** Pipe Seal Cond: **Unknown**
